Bedding-Parallel Shear Zones as Landslide Mechanisms in Horizontal Sedimentary Rocks

MICHAEL W. HART

Key Terms: *Bedding-Parallel Shear Zones, Landslide Mechanisms, Horizontal Sediments, Gravitational Creep, Progressive Failure*

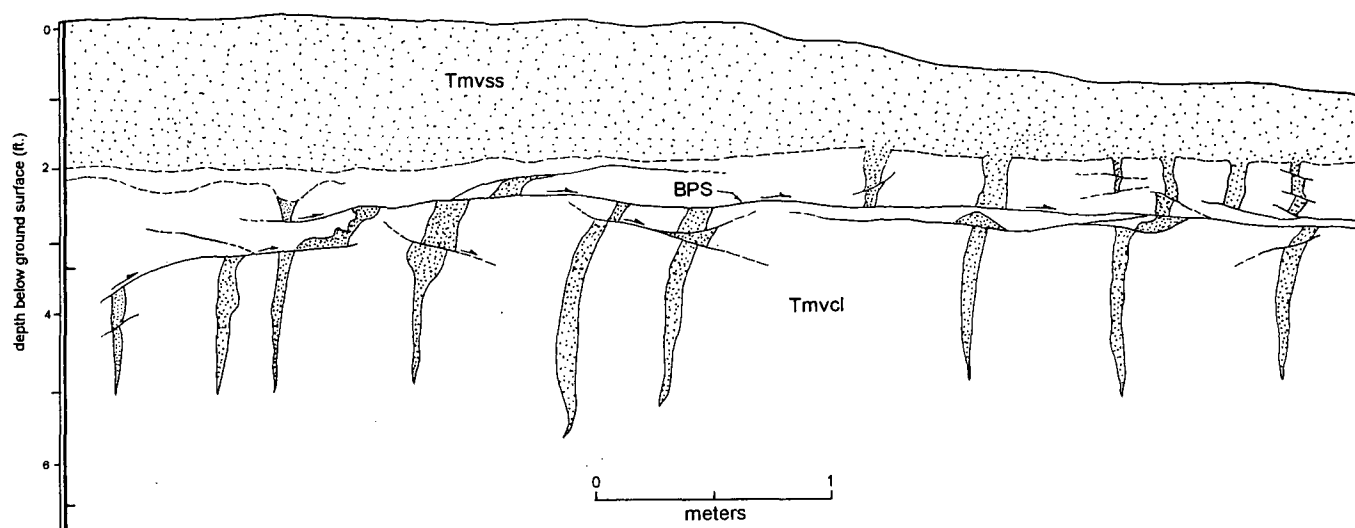
Figure 2. Horizontally offset sandstone-filled desiccation cracks in claystone of the Eocene Mission Valley Formation. Orientation of section is perpendicular to the natural slope. Arrows indicate apparent slip direction of filled desiccation cracks oriented at high angles to the plane of section. Tmvss = Mission Valley Formation, massive white sandstone; Tmvcl = fissured claystone; BPS = bedding parallel shear zone.

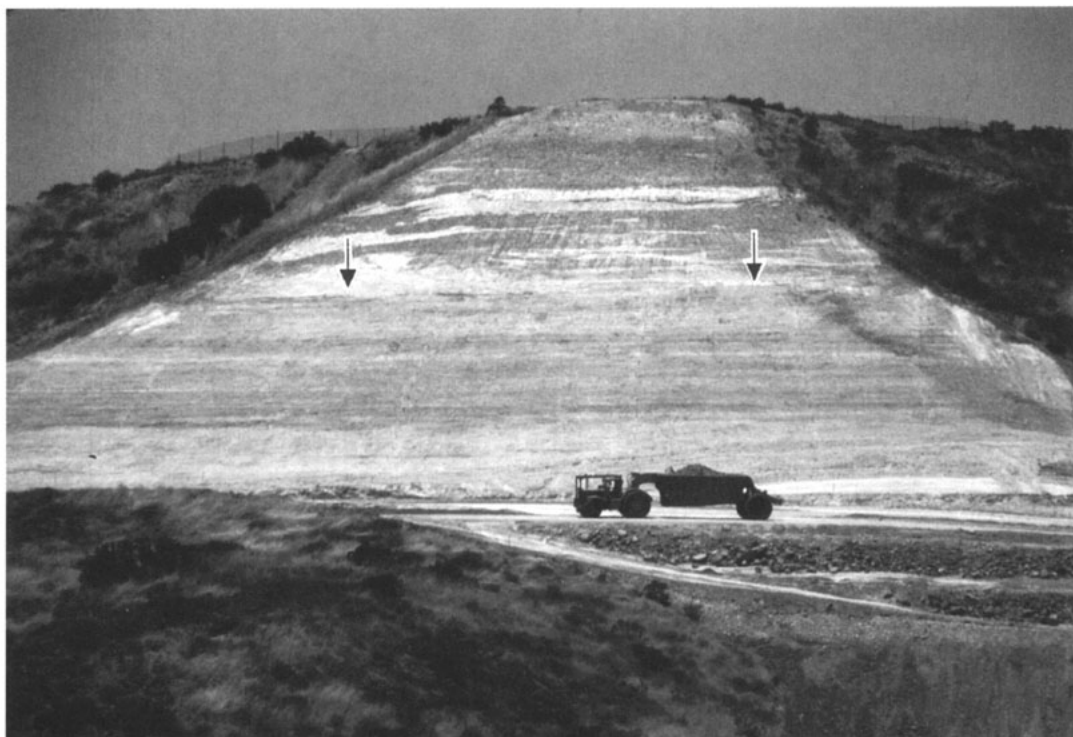
This exposure is somewhat atypical in that the BPS occurs in a 2- to 3-cm thick, horizontal claystone bed within a thick sequence of sandstone and conglomerate. In most other localities in the greater San Diego area, BPS occur in exposures dominated by finer grained sediments such as siltstones and claystones. The BPS is characterized by two planar slip surfaces located at the top and bottom of the gouge zone. The gouge varies in thickness from paper thin to several inches (the full thickness of the clay bed). An analysis of the clay indicates it is 100 percent smectite, typical of other waxy bentonites of San Diego County. In a sieve analysis, 99 percent of the material passed the #200 sieve. Of the 1 percent

Figure 4. View of Highway 52 cut slope looking north. BPS (arrows) occurs in a thin claystone bed within a sequence of Eocene sandstone and conglomerate.

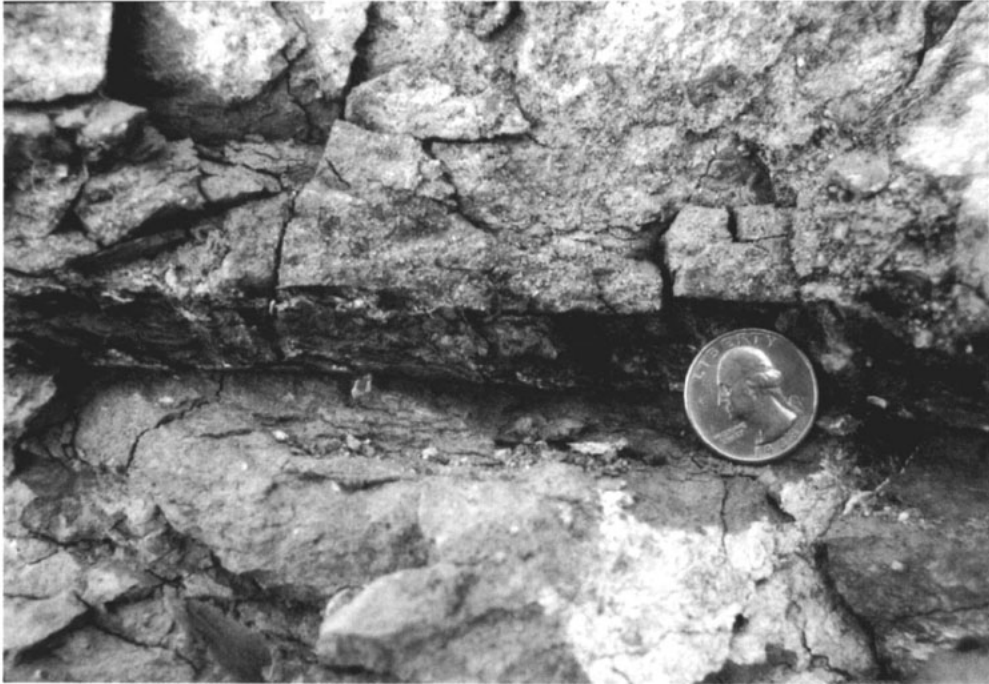
The BPS dies out to the east in a carbonate-rich zone as it approaches the ground surface. This apparent die out is likely a result of weathering and replacement of the clay which has essentially destroyed the shear fabric near the ground surface. The Vail Lake exposure is similar to the Highway 52 exposure discussed previously in that the BPS occurs in a relatively thick sequence of coarse-grained sediments. A landslide origin for the shear zone is ruled out by examination of the well-exposed geologic structure in the cut slopes, as well as a lack of recognizable landslide morphology on the adjacent natural slopes.

Figure 6. BPS at the Vail Lake locality (dark zone behind coin with 2.5 cm diameter). Shear zone occurs in a 3- to 5-m high vertical road-cut within a sequence of sandstone and siltstone.

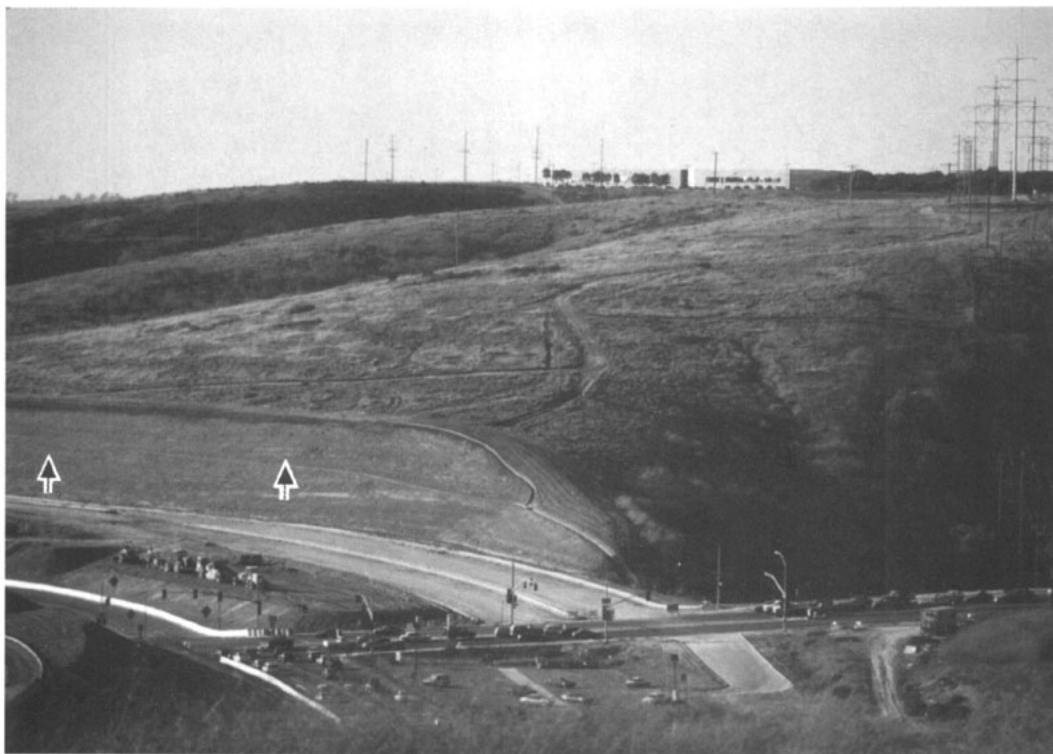
siltstone and fine sandstone exposed in the cut slope provide good evidence that the BPS was not caused by landsliding (Figure 8).

Figure 8. Vista Sorrento Parkway cut slope excavated into uniform natural slope lacking landslide morphology. The BPS (arrows) occurs just below the drainage bench at mid-height of the slope. Location of cut slope is depicted in lower right corner of Figure 7.

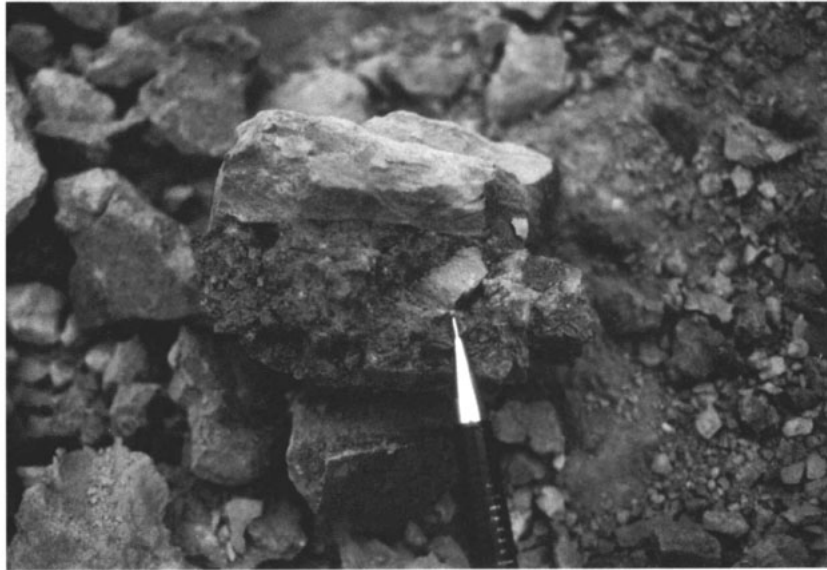
Figure 9. Approximately 2.5 cm thick gouge zone of Vista Sorrento Parkway BPS. Note the angular clast of siltstone at tip of pencil.

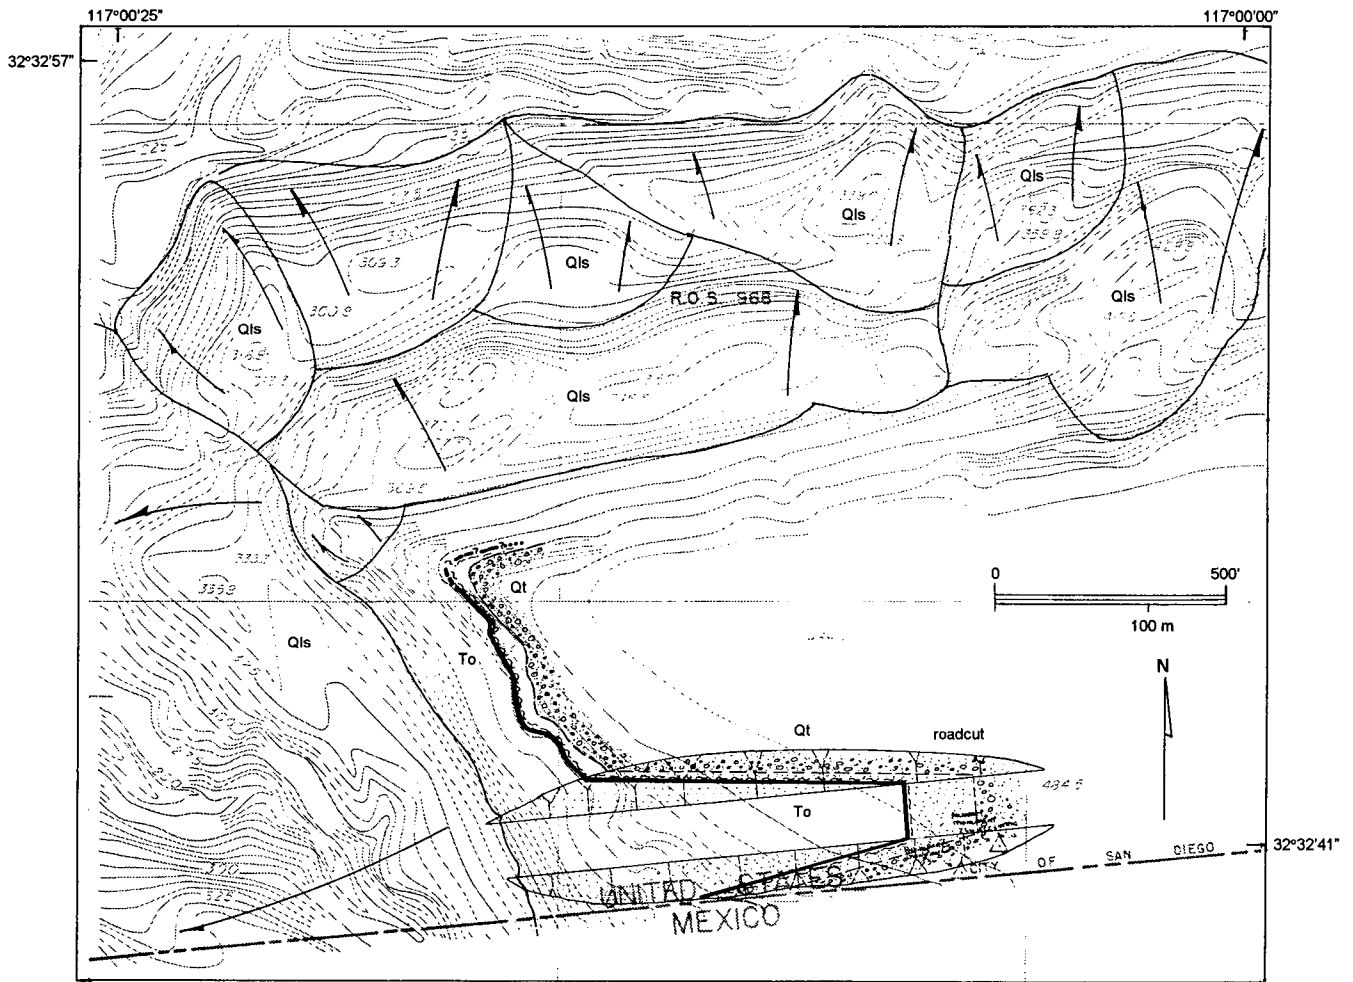
At a distance farthest from the bluff face the BPS occurs in an approximately 15-cm thick bentonite clay bed. The zone of shearing is characterized by two sub-parallel BPS separated by 8 cm of fractured, but not sheared, bentonitic dark brown claystone. The upper BPS is a poorly developed, subhorizontal gouge zone overlain by hard, clayey siltstone. The lower BPS is characterized by approximately 5 mm of soft, moist gouge and a well-developed planar slip surface underlain by hard, blocky, pink bentonite. Approximately 60 m west of the above locality in the approximate center of the cut, the remolded clay zones were slightly thicker and better developed (Figure 11).

Figure 10. Border Patrol roadcut and geologic map. Roadcut occurs on west-facing slope of a mesa rimmed with translational landslides. BPS (heavy solid line) occurs in a horizontal bentonite bed. Qls = translational landslide; Qt = Lindavista Formation (marine terrace deposits); To = Otay Formation. Contour interval is 5 ft.

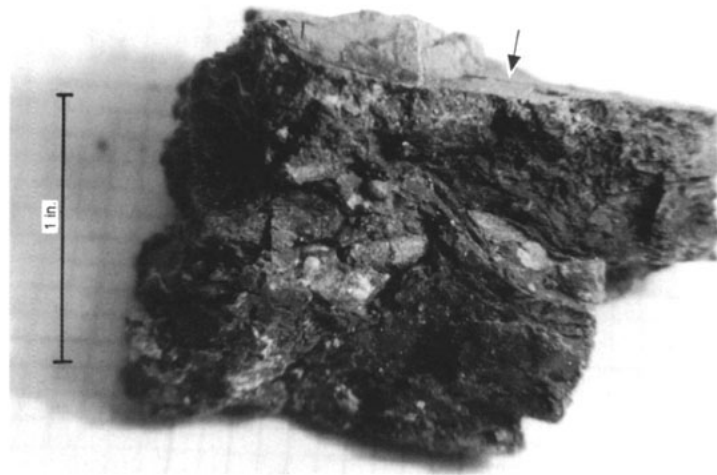
Figure 11. Gouge zone showing anastomosing shears and upper slip surface (arrow) of BPS in Border Patrol roadcut.

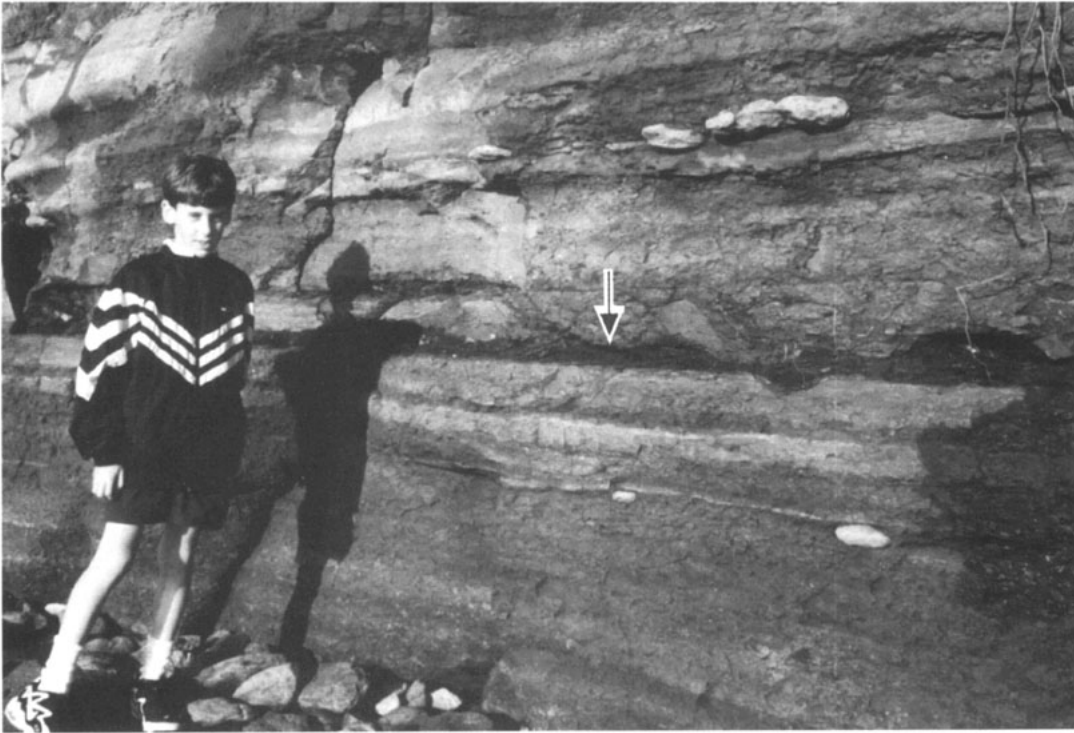
Geologic mapping of the sea-cliff immediately after the 1996 landslide revealed that this landslide, as well as the two older landslides, failed on the lowest of two BPS exposed in the cliff (Figure 13). The lower BPS is exposed continuously at the base of the sea-cliff (except where buried by the 1996 landslide) from the southern edge of the Beacons Beach landslide to the southernmost prehistoric landslide, a distance of approximately 310 m where it is terminated by a fault.

Figure 13. BPS (arrow) near base of sea-cliff, Leucadia, California. Note pinch-and-swell nature of gouge zone suggesting squeezing of clay bed and plastic flow.

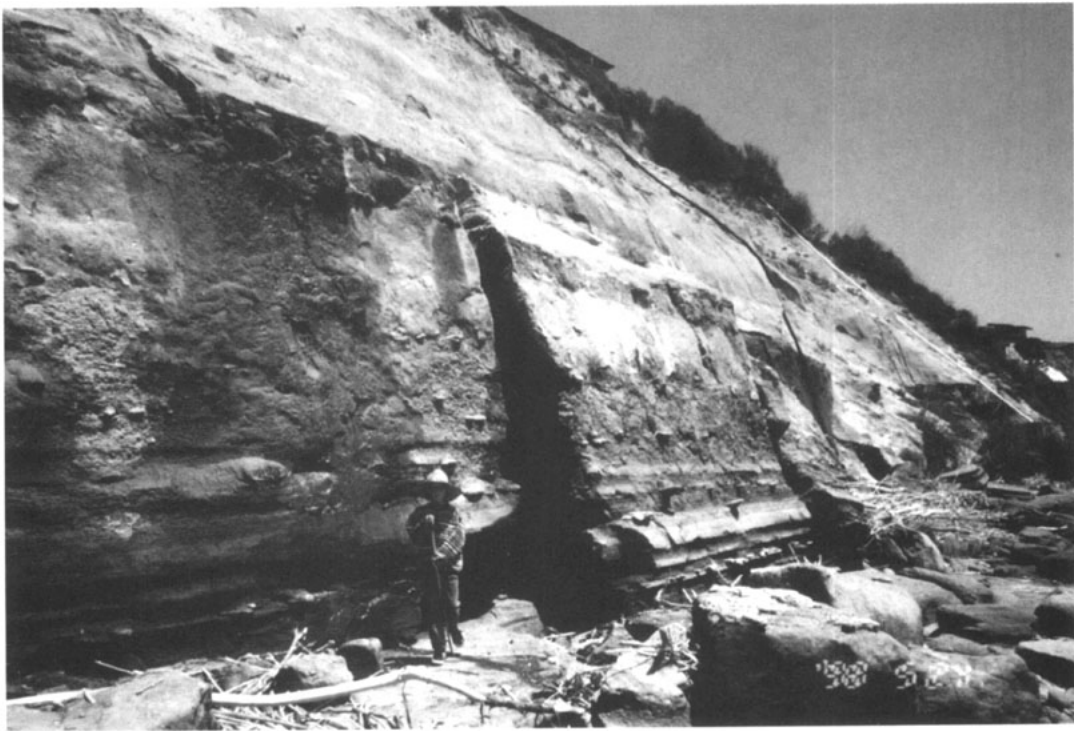
Figure 14. Unique mode of block failure, Leucadia, California. Block in center of photo failed by translating seaward on BPS at base of slope resulting in backward rotation of block.

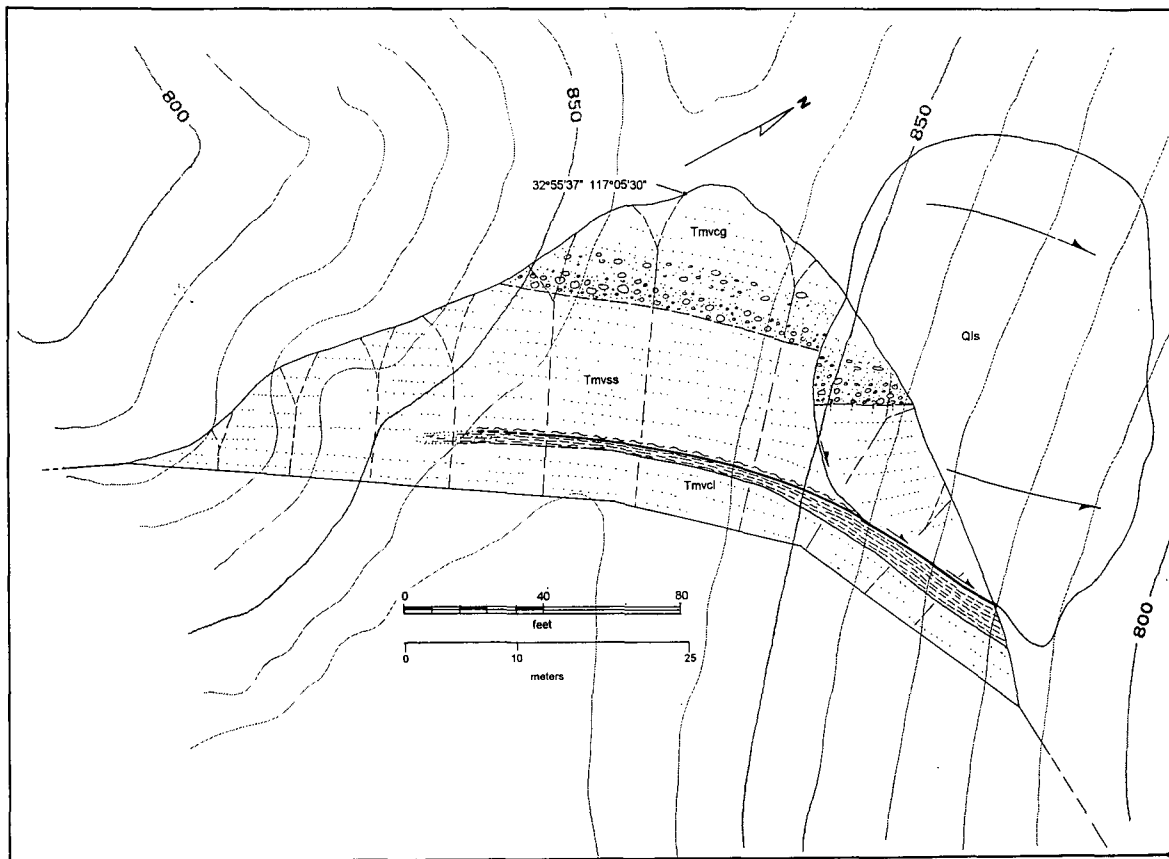
narrow ridge (Figure 15). The shear zone occurs at the top of a 1-m thick claystone bed and could be traced continuously for nearly 60 m across the face of the cut to where it merged with the basal rupture surface of a small landslide. The BPS became less well developed in a westerly direction and died out gradually as the clay-rich sediments graded into fine-grained sandstone. This exposure was significant for several reasons; first, it showed the discontinuous nature of BPS and that they may die out laterally in coarse-grained sediments; second, the exposure demonstrated how landslides utilize BPS as their basal rupture surface. Lastly, the exposure's unique physical location, extending through the center of a ridge and the fact that it was observed to die out gradually in a sandstone, is convincing evidence that BPS are not merely misidentified landslide slip surfaces are but distinct features caused by a totally different mechanism.

Figure 15. Sketch of cut slope in Scripps/Miramar subdivision, San Diego, California. BPS is heavy solid line near base of slope on top of clay bed. Note that BPS dies out as clay bed grades into sandstone near west end of cut slope. Landslide has utilized BPS as basal rupture surface. Qls = Landslide; Tmvcg = Mission Valley Formation, conglomerate; Tmvss = sandstone; Tmvcl = claystone.

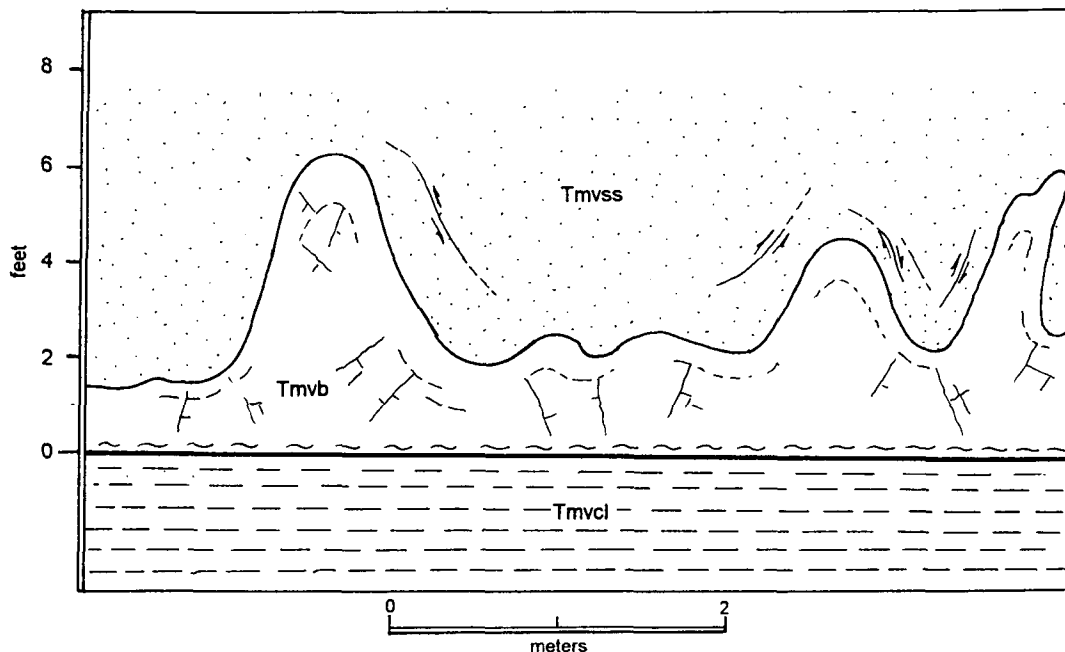
Figure 17. BPS (heavy black line) developed at base of plastically deformed bentonite bed (Tm vb) in Mission Valley Formation, San Diego, California. Tm vcl = Mission Valley Formation claystone; Tm vss = sandstone.
