The Presidio Park Graben San Diego, California

Mike Hart
Hart Geologic Services
mwhart@aol.com

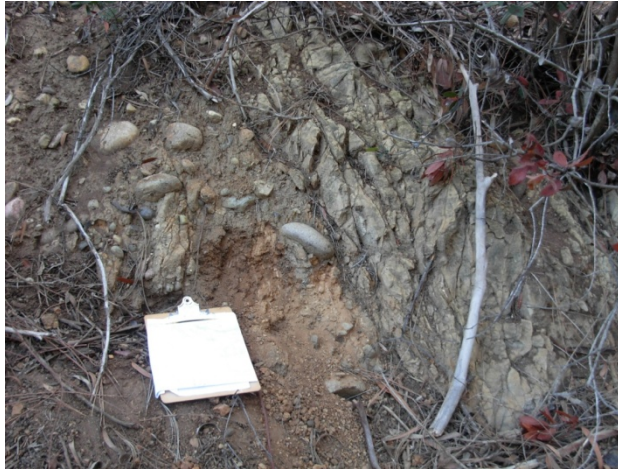
Figure 2. The south graben fault juxtaposing Lindavista Formation on the left and Mission Valley formation on the right. (Location B, Geologic Map, Figure 1)

The southern fault that defines the graben is exposed at two localities; along a trail on the west side of the northwest trending ridge south of the previously described parking lot (Location B, Figure 1, and Figure 2,) and in the road cut leading to the parking lot described above. At this locality the fault juxtaposes red-brown sandstone of the Lindavista Formation with light-brown thinly-bedded sandstone of the Mission Valley Formation. Several additional faults that bound a secondary down-dropped block of Lindavista formation are also exposed in the road cut.

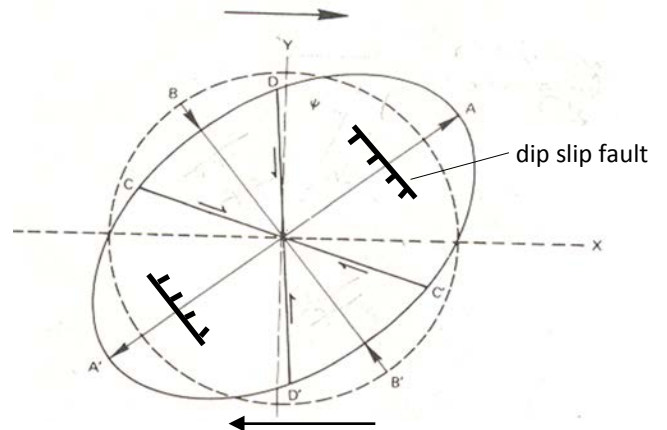
Figure 3. Strain ellipse showing forces and structures resulting from wrenching deformation.

The Presidio Park Graben owes its existence to forces associated with movement along the adjacent Rose Canyon fault. The strain ellipse in Figure 3 shows the forces and structures that can result from wrenching deformation. The arrows at top and bottom of the diagram are the directions of the principal stress and line C-C' represents a right-lateral fault resulting from

wrenching. Dip-slip faults such as those bounding the Presidio Park Graben generally occur perpendicular to Line A-A'; the direction of extension.

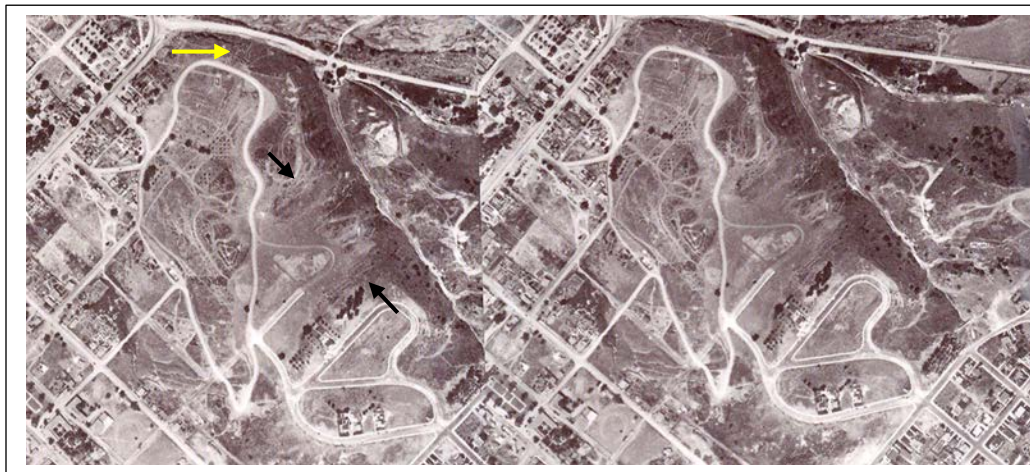
Figure 4. San Diego County 1928 photographs of Presidio Park area. Black arrows point to northeast trending fault scarps bounding the Presidio Park Graben. Yellow arrow points to possible right-lateral offset of valley wall. Geologic map Figure 1 shows a pressure ridge and possible closed drainage south of the road below the yellow arrow that may be evidence of a landslide or an active fault.
